### **UAC's HT6 Compressor Improvement**

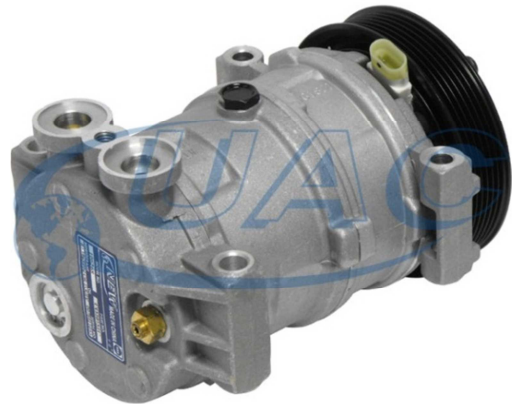
**CO 20151C** is a similar design to a Nippondenso compressor 10PA17 with five pistons or ten cylinders. The case is pinned, which keeps the compressor sections aligned and prevents leakage. In addition, this design operates more quietly and efficiently.

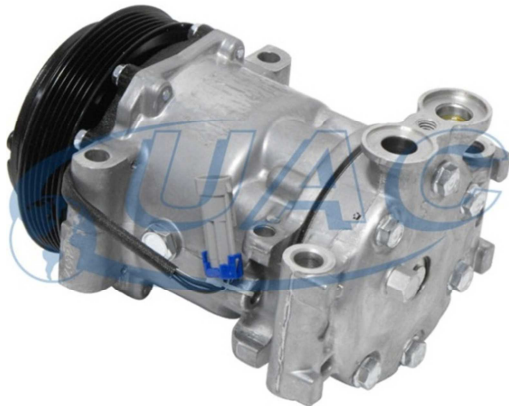
**CO 4440C** compressor has a similar design to a Sanden seven cylinder compressor. This compressor also offers the pinned case and quiet operation preferred by most Sanden loyalists.
