UAC's HT6 Compressor Improvement

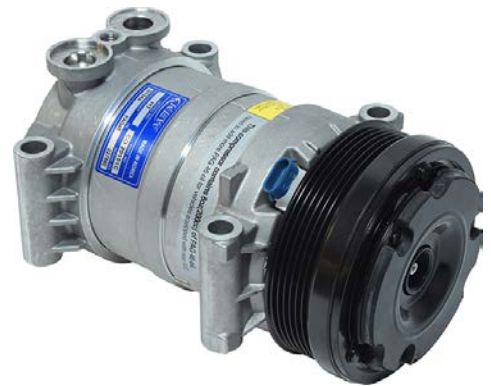
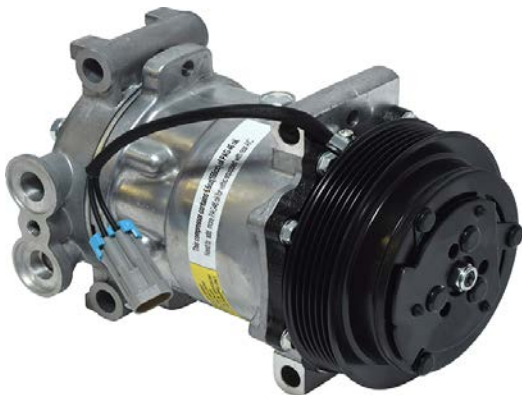
CO 20151C is a similar design to a Nippondenso compressor 10PA17 with five pistons or ten cylinders. The case is pinned, which keeps the compressor sections aligned and prevents leakage. In addition, this design operates more quietly and efficiently.

CO 4440C compressor has a similar design to a Sanden seven cylinder compressor. This compressor also offers the pinned case and quiet operation preferred by most Sanden loyalists.
